ROCKBURSTS IN ONTARIO MINES DURING 1985

D.G.F. Hedley

CANMET Special Publication

SP87-2E

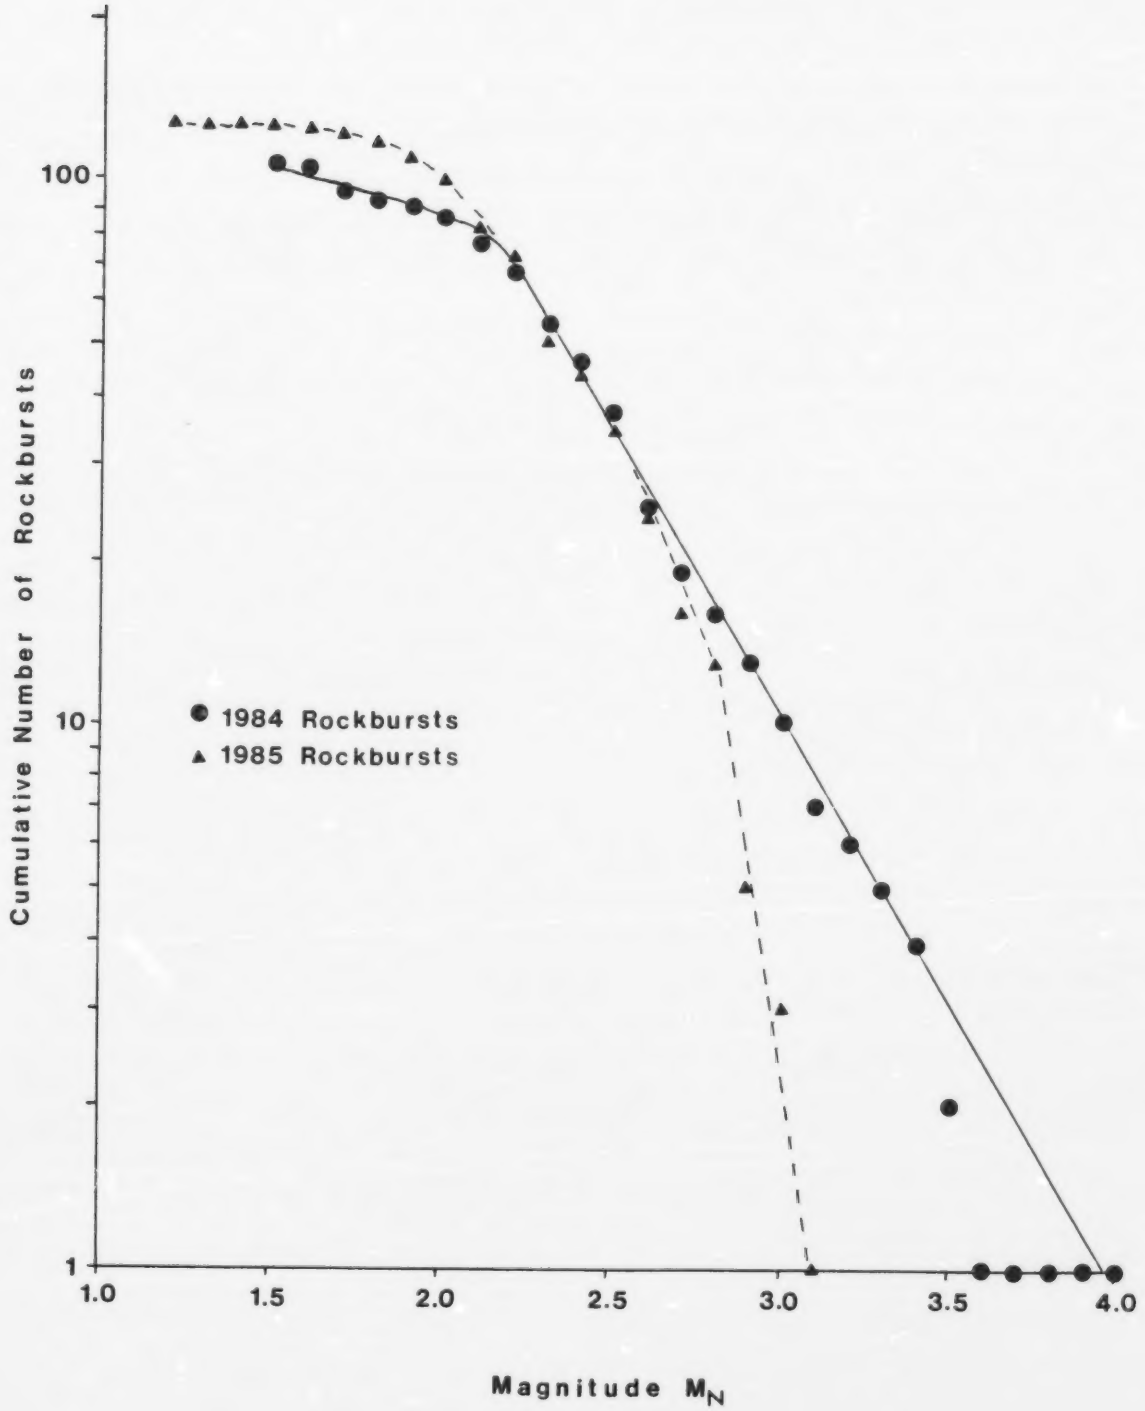
Fig. 1 - Frequency-magnitude relationships

The frequency of rockbursts of varying magnitude (M_N) is plotted as a semi-log relationship in Figure 1 together with the curve for the 1984 rockbursts. The straight-line relationship between M_N = 2.1 to 3.5 observed in the 1984 results is only evident between M_N = 2.1 to 2.7 in 1985. The sections of the mines (i.e., Falconbridge No. 5 Shaft and Creighton) that experienced large rockbursts in 1984 were closed down immediately after those occurrences. Consequently, neither mine contributed to the 1985 activity, which could explain some of the decrease in the number of large rockbursts.

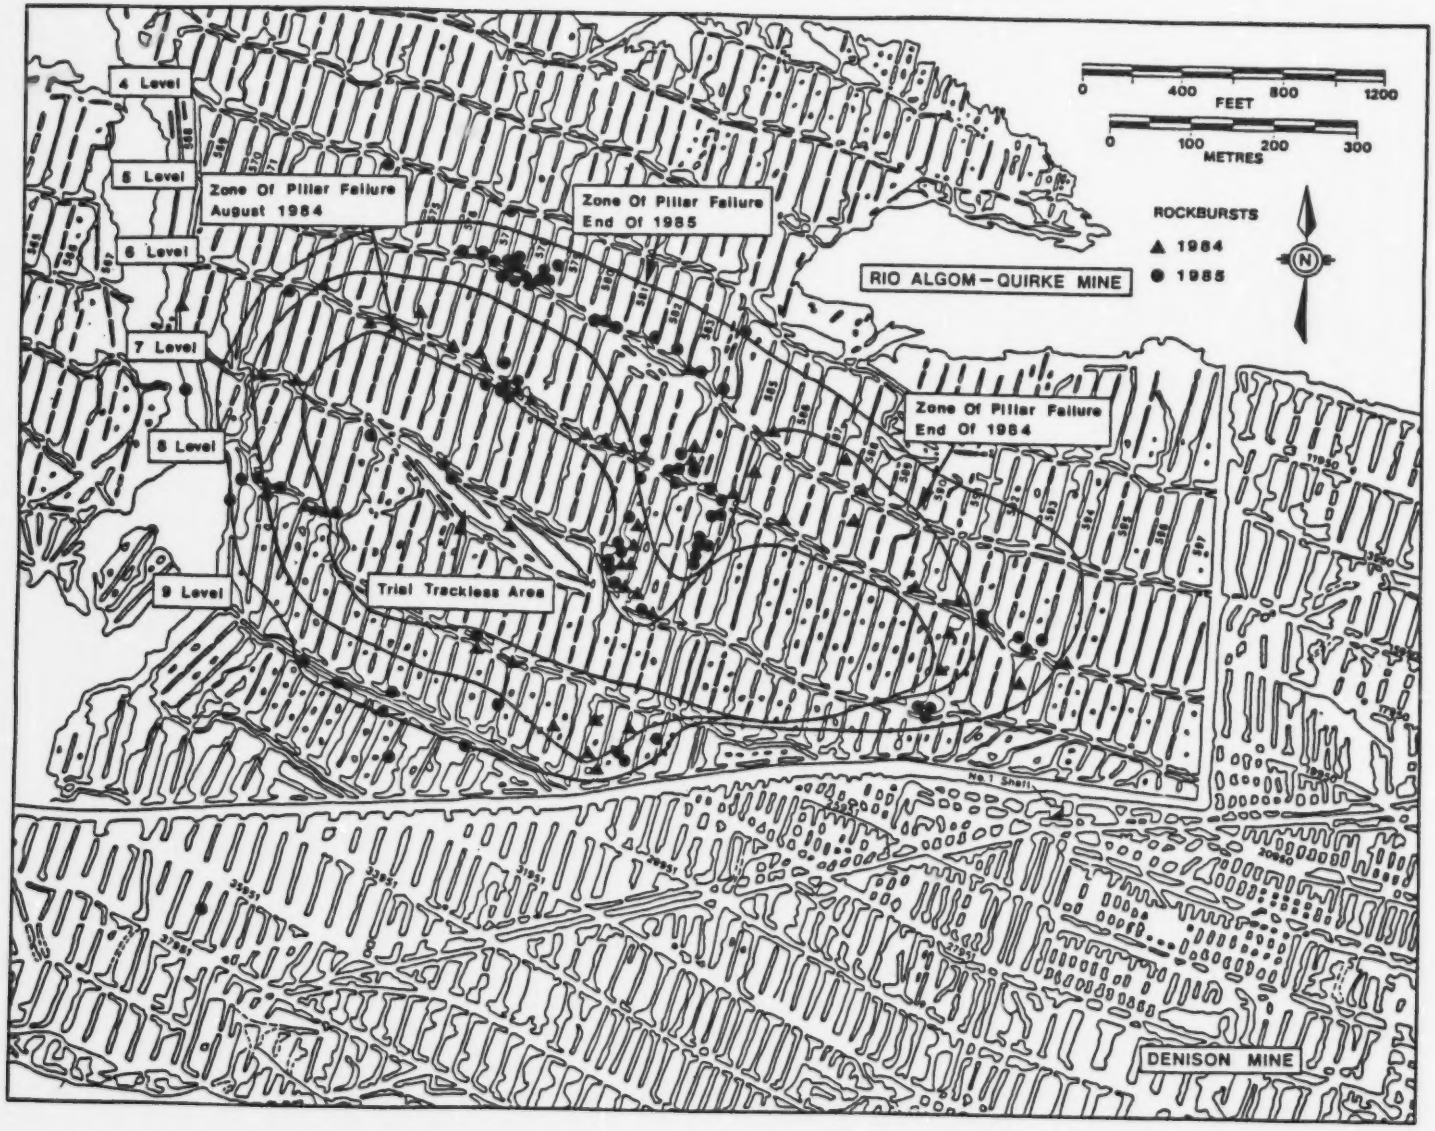
Fig. 2 - Partial plan of Quirke and Denison mines showing 1984/85 rockburst locations

Rockburst activity in 1985 at Rio Algom's Quirke Mine was a continuation of that which began in September 1984. All the 59 events of 1984 and the 88 events of 1985 (see Table 1) are plotted on a partial plan of Quirke Mine and the adjacent Denison Mine in Figure 2. Both companies are mining the same gently dipping conglomerate reefs using a stope (or room) and pillar layout.

By August 1984, it was estimated that the zone of pillar failure at Quirke Mine extended 870 m on strike by 300 m on dip (see Fig. 2). Some large pillars just to the northeast of a trial trackless area were holding back failure in this area. At that time, it was still considered that the main roof was spanning the failure zone without major breakdown.

Major rockburst activity in the pillars occurred again in September 1984, and continued almost without interruption until April 1985, and sporadically after that. First, the sill pillars on the 6 level failed, increasing the span on dip to 420 m. In February 1985, the 5 level sill pillars failed, increasing the span to 520 m, and, during August and September 1985, the 9 level sill pillars failed, increasing the span to 600 m on dip. The affected area also expanded to the east and west, and there was a large concentration of rockbursts around the large pillars northeast of the trackless area. By the end of 1985, the estimated zone of pillar failure extended about 1100 m on strike by 600 m on dip (see Fig. 2).

Two isolated rockbursts occurred in Denison Mine during January 1985. One of these is plotted on Figure 2 south of Quirke Mine; the other occurred about 1200 m east of Quirke Mine.

Both the seismic and water inflow data suggested that the hanging wall had fractured above the rockburst zone, centred on the trial trackless area. The first major breakdown probably occurred during December 1984, when the partially supported span on dip was 420 m. This breakdown accelerated in February 1985, when the span increased to 520 m and, in September 1985, to 600 m. The average depth below surface in this area is about 500 m. It is interesting to note (see Fig. 2) that no rockbursts have been recorded at the centre of the eastern part of the rockburst zone. The partially supported span on dip is about 360 m in this area.

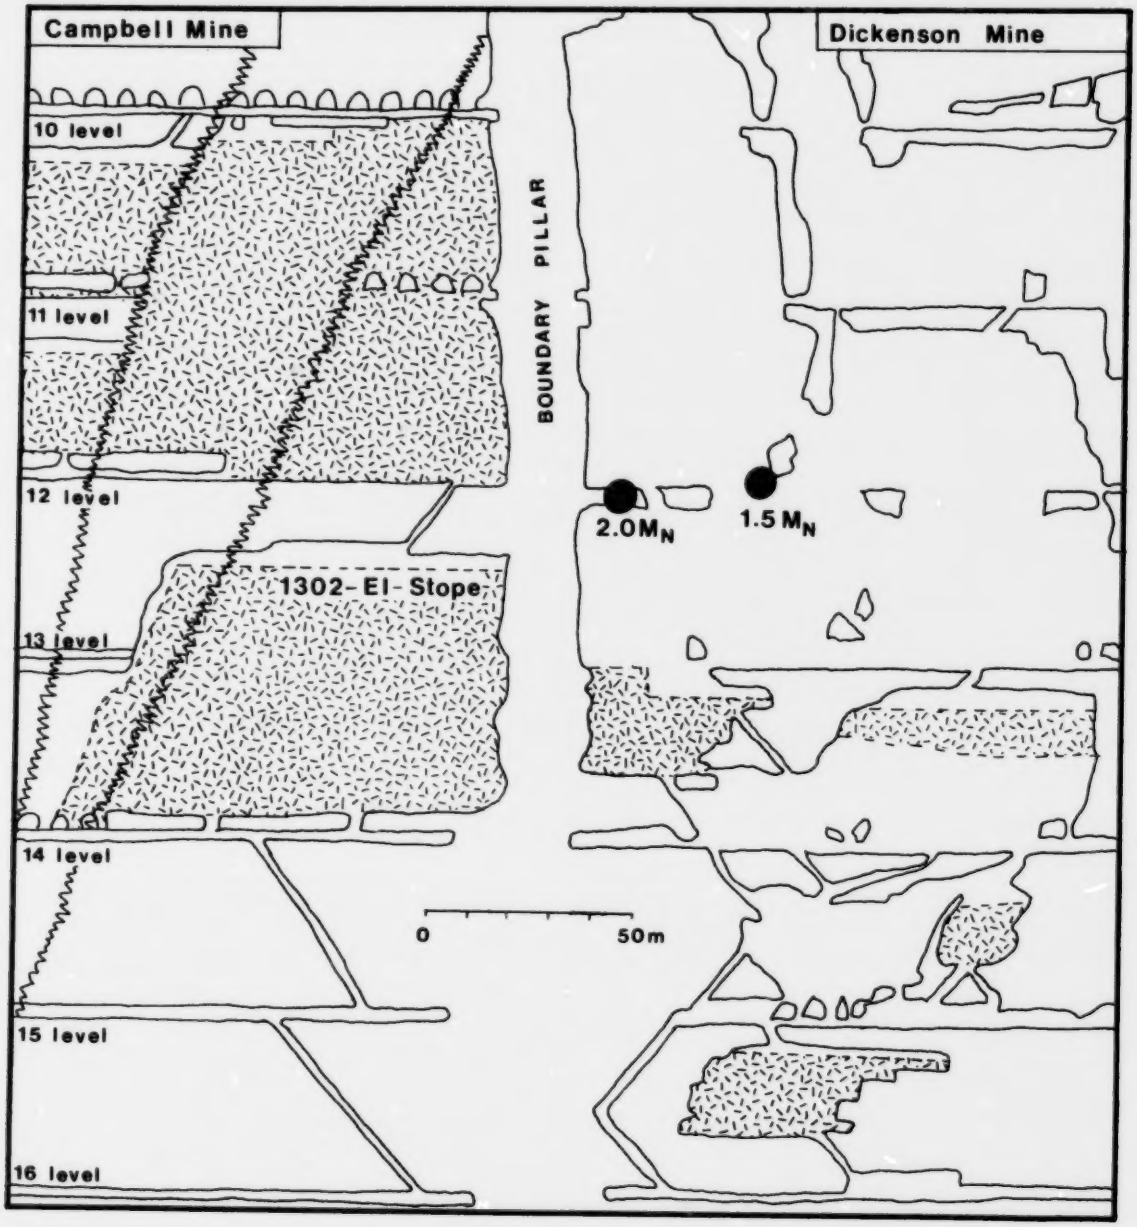
Fig. 3 - Rockbursts around the boundary pillar between Campbell and Dickenson mines

The two rockbursts in Dickenson Mine, during December 1985, occurred near old, mined-out shrinkage stopes next to the boundary pillar with Campbell Mine (Fig. 3). These stopes were not backfilled. The most likely trigger of these rockbursts was the mining in cut-and-fill stope 1302-E1 on Campbell's side of the boundary, some 50 m to 90 m from where the rockbursts occurred. Campbell's microseismic system gave reasonable source locations using a "Block Solution." However, the source could not be verified because of lack of access on the Dickenson side.

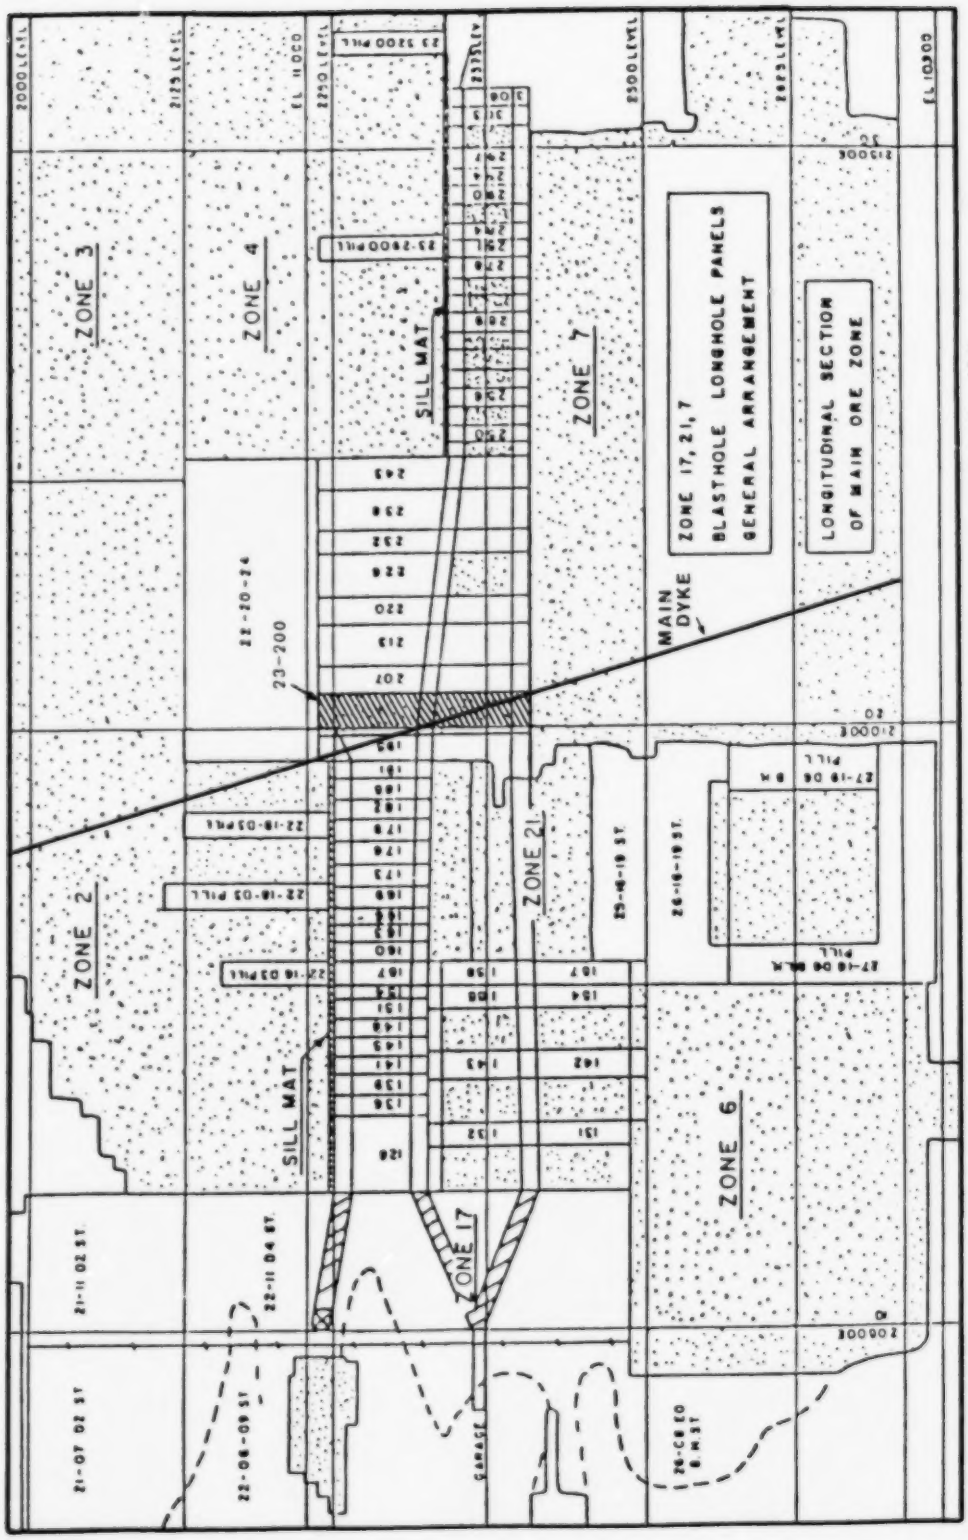
Fig. 4 - Longitudinal section of Strathcona Mine with blasthole layout

Figure 4 is a longitudinal section of the west end of the orebody showing the blasthole layout for mining the main sill pillar. The main diabase dyke intersects the 23-200 panel, which was one of the first stopes mined in this block. Figure 5 is a plan of the undercut level for the 23 level stopes, showing the blasting sequence in the 23-200 panel. In addition, the main and branch dyke systems are shown, together with the locations of major damage.

It appears that the main mechanism of rockbursts at the Strathcona Mine is fault slippage. The main- and branch-dyke systems can be considered as a shear plane with associated tension gashes. Mining the 23-200 panel altered the stress regime on the main dyke and allowed minor stick-slip on the slickensided planes. Accumulated slippage along this dyke would eventually reactivate the branch dykes. On the hanging wall side damage occurred in a series of small seismic events, whereas on the footwall side the magnitude and damage was much greater.

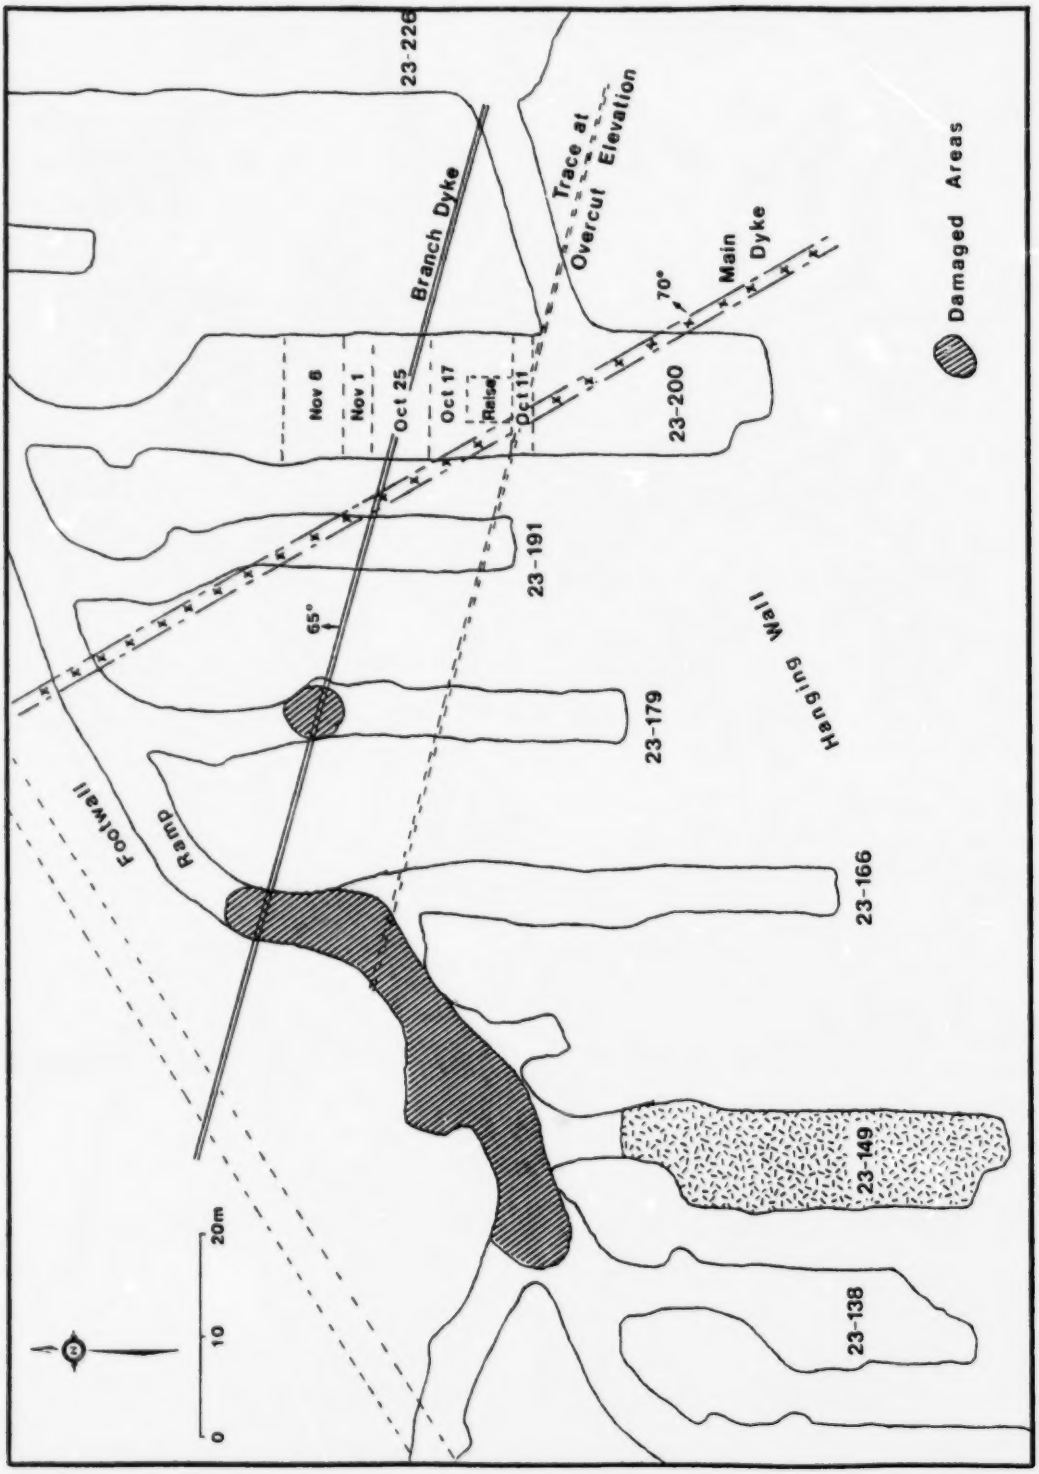
Fig. 5 - Plan of 23 level undercut showing geologic structure, blasting sequence and damage

About 90 minutes after the production blast on November 8 a major rockburst of magnitude 2.2 occurred. Damage was found on the footwall ramp and minor water seepage was observed on the branch dyke where it intersects the 23-179 stope. Blasting was stopped in the 23-200 panel to rehabilitate the ramp area. On November 17, a rockburst of magnitude 2.7 occurred, which caused more damage to the ramp and to 179 undercut. However, the 200 panel and the intersection of the main dyke with the ramp were not affected. Additional rockbursts of magnitude 2.2 and 2.3 on November 19 and December 18 occurred in the same area.

On December 21, a 3.1-magnitude rockburst completely destroyed the ramp over a distance of 50 m with caving extending up to 10 m above the original roof. The entire area was subsequently abandoned and the damaged area was backfilled, including the 23-200 panel.

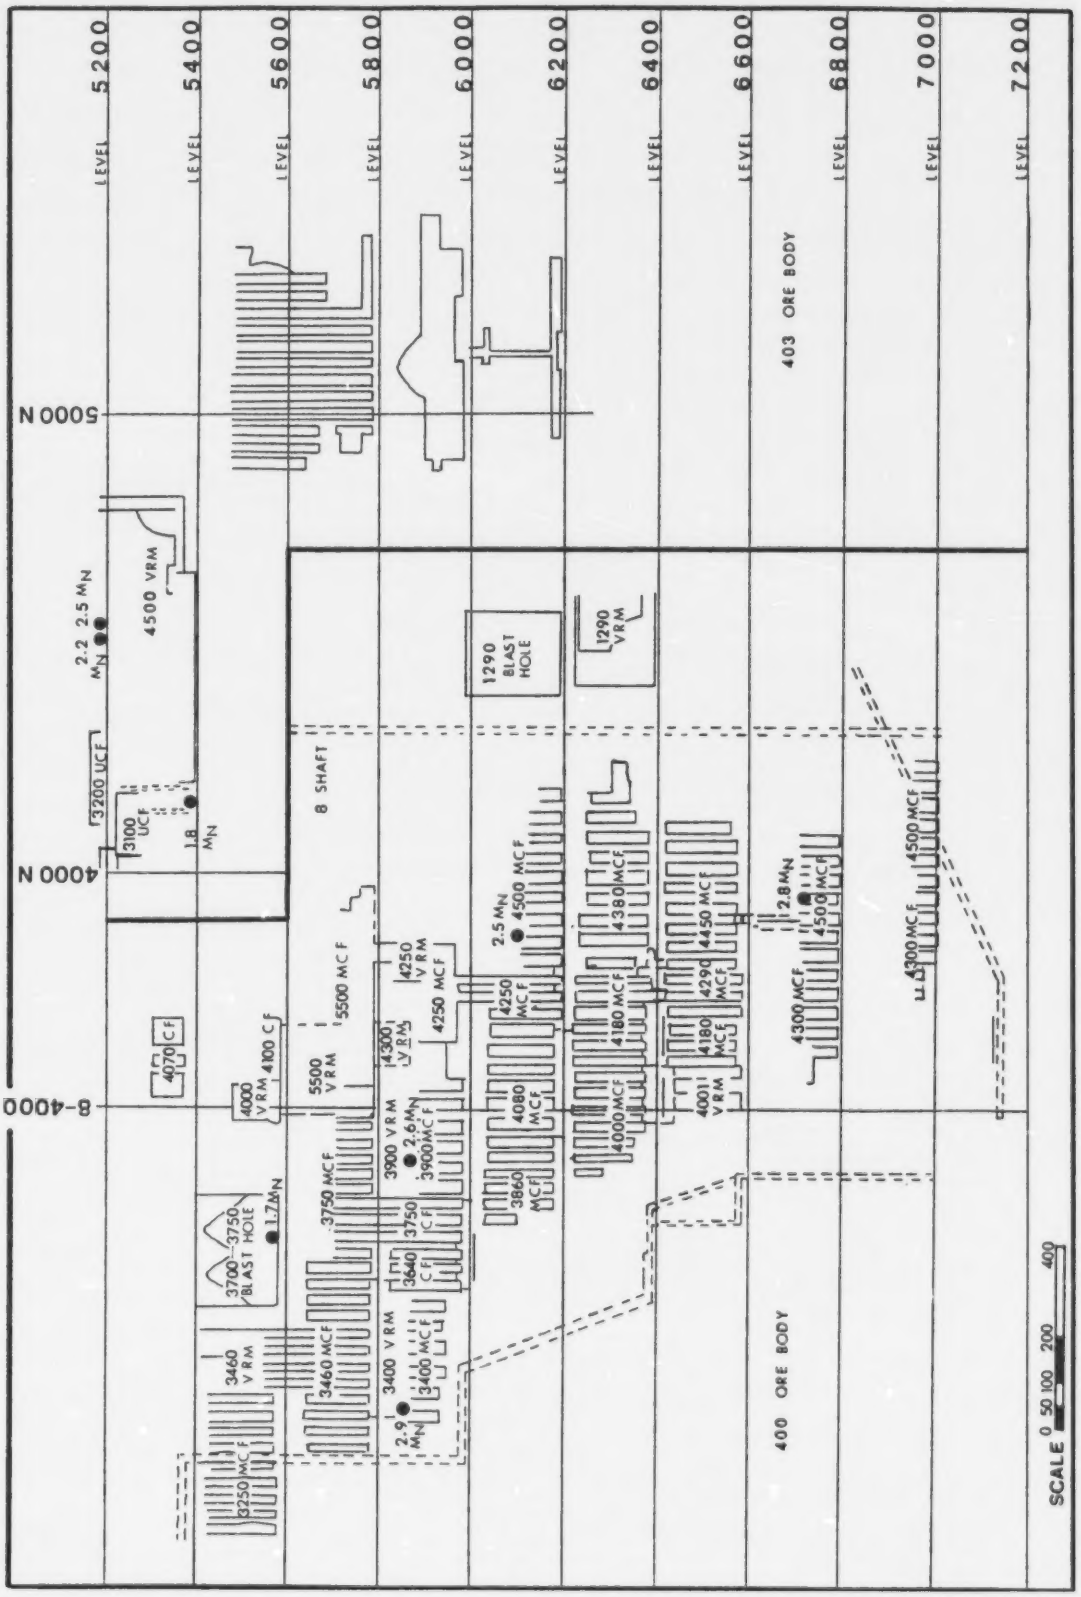
Fig. 6 - Composite longitudinal section showing location of rockbursts at Creighton Mine in 1985

Both orebodies have a history of seismicity including rockbursts resulting from the high stress conditions encountered at depth. The locations of eight of the nine 1985 rockbursts, as determined from the microseismic system, are plotted in Figure 6. Six of the rockbursts occurred in the 400 orebody and three in the 403 orebody.

Most of the rockbursts in the 400 orebody were located in the backs of cut-and-fill stopes, which had progressed at least half their height to the level above. These could be seen as bursting of the crown pillars, and the magnitudes were relatively high; 2.5 to 2.9. The 2.6-magnitude event on the 5000 level was located where a quartz diorite dyke intersects a footwall drift. On the 5600 level, a 1.7-magnitude rockburst occurred in the drawpoint of a blasthole stope.

In the 403 orebody a 1.8-magnitude event was located in the chutes of an undercut-and-fill stope. On 2 November 1985, two rockbursts occurred within an hour of each other on the 5200 level and 2 1/2 hours after a blast in the crown pillar of an adjacent VRM stope. Coincidentally, a rockburst of 2.9 magnitude occurred in the 400 orebody some 6 hours earlier. All the 1985 rockbursts at Creighton Mine took place near active mine workings and the mining activity was probably the triggering mechanism.

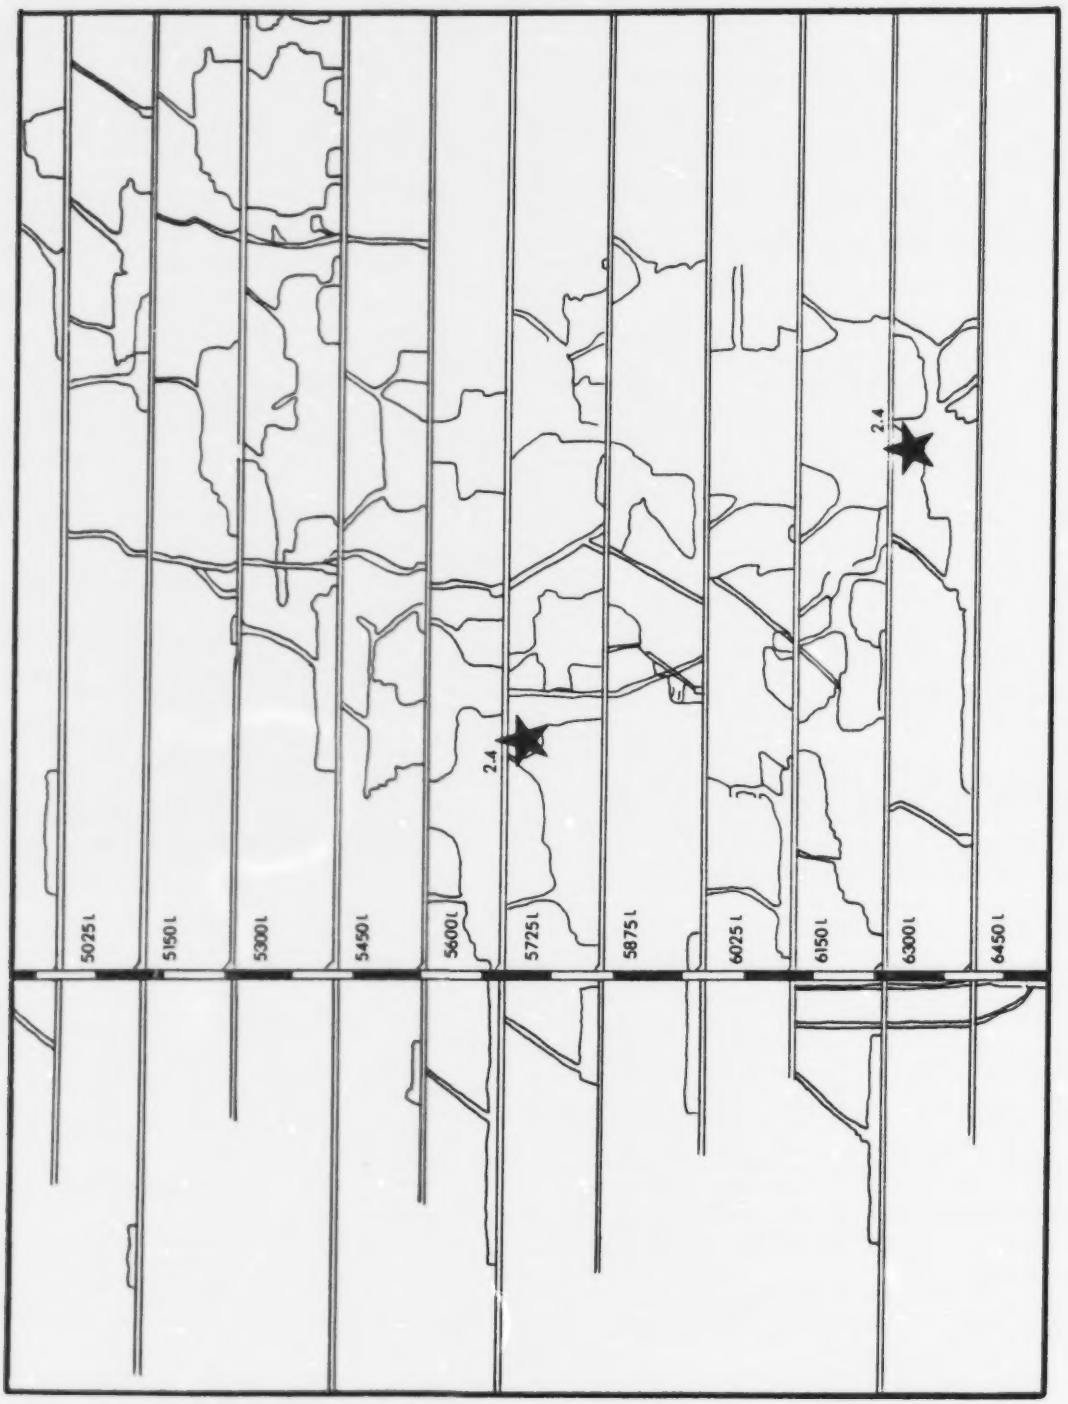
Fig. 7 - Longitudinal section of the west end of Macassa Mine showing locations of 1984 rockbursts

Only three rockbursts were recorded at Macassa Mine in 1985 (see Table 4), which was a decrease from five in the previous year. No damage could be found for the third rockburst, hence its location is unknown. The first two rockbursts, both of 2.4 magnitude, occurred in sill pillars above cut-and-fill stopes, at depths of 1745 m and 1950 m (Fig. 7).
